KIRKLAND & ELLIS LLP

# PG&E Independent Monitor Report of November 19, 2021

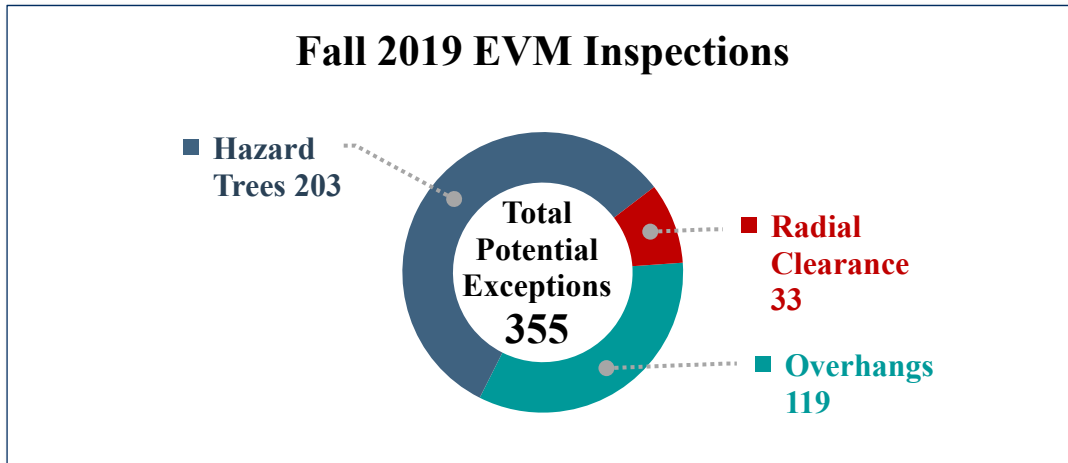
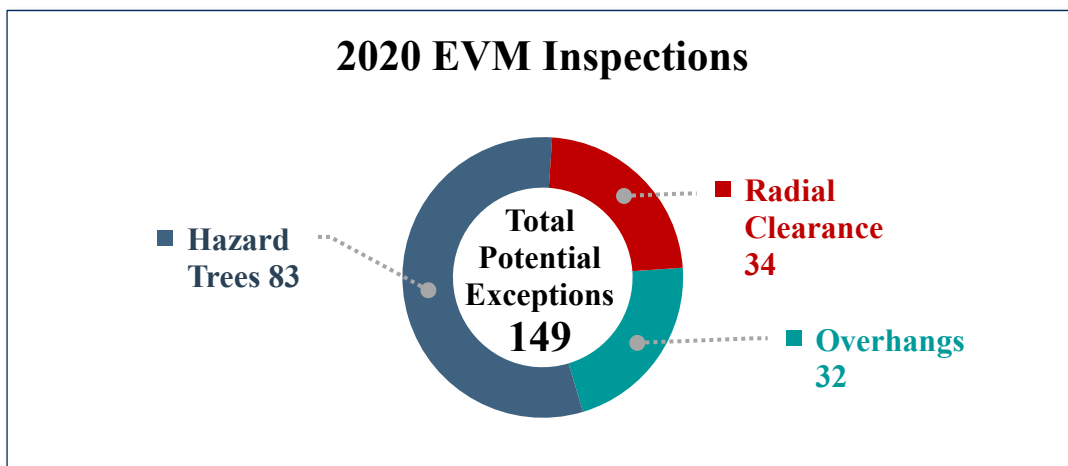
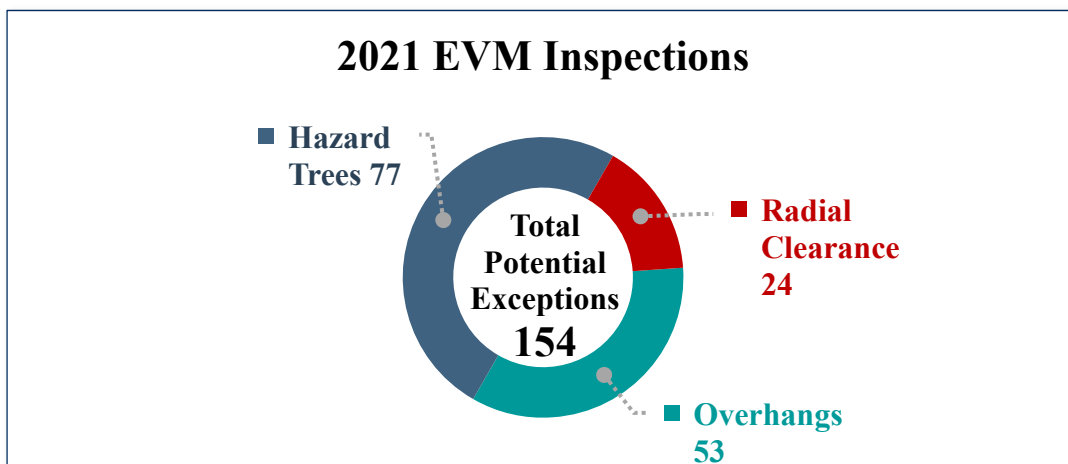
**EXHIBIT 4: EVM INSPECTION STATISTICS**

For Monitor team inspections of EVM areas from 2019-2021, the three graphs below show the number of potential exceptions observed.

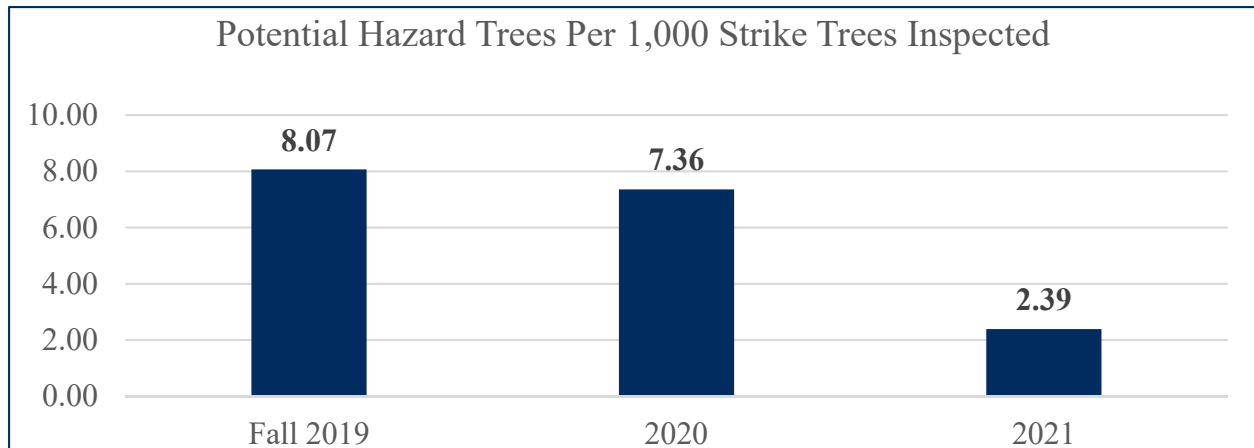
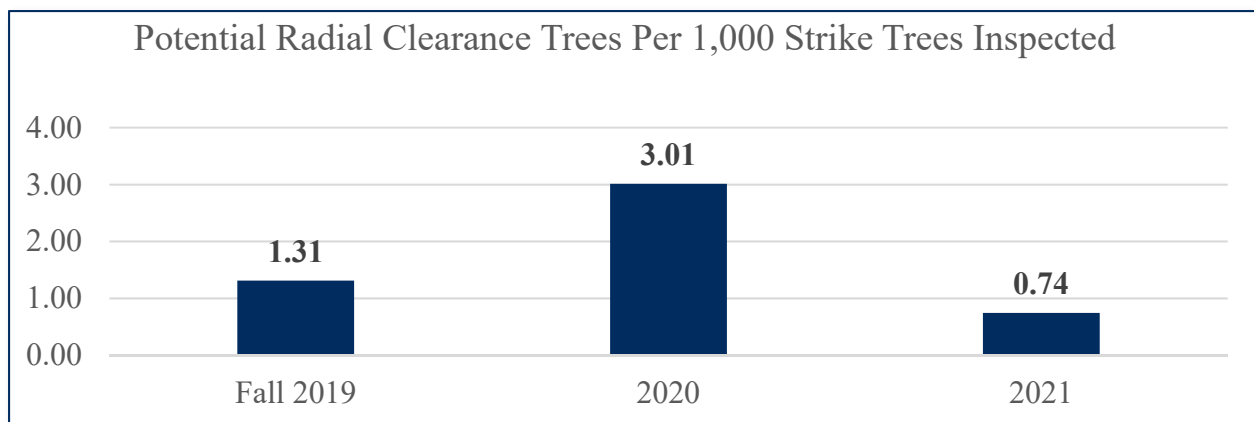
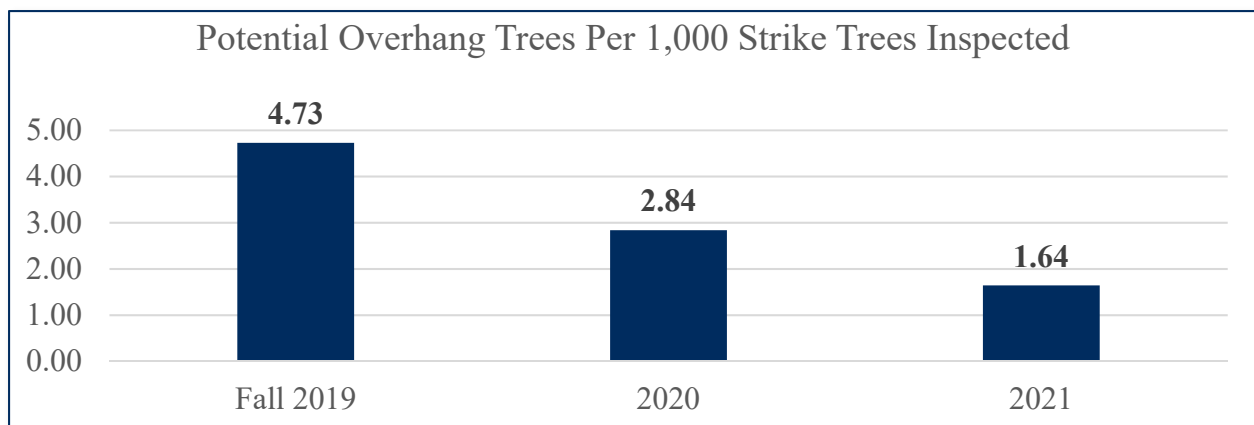
For Monitor team inspections of EVM areas from 2019-2021, the first graph shows the number of potential hazard trees observed per 1,000 strike trees inspected, the second graph shows the number of potential radial clearance issues observed per 1,000 strike trees inspected, and the third graph shows the number of potential overhang trees observed per 1,000 strike trees inspected.

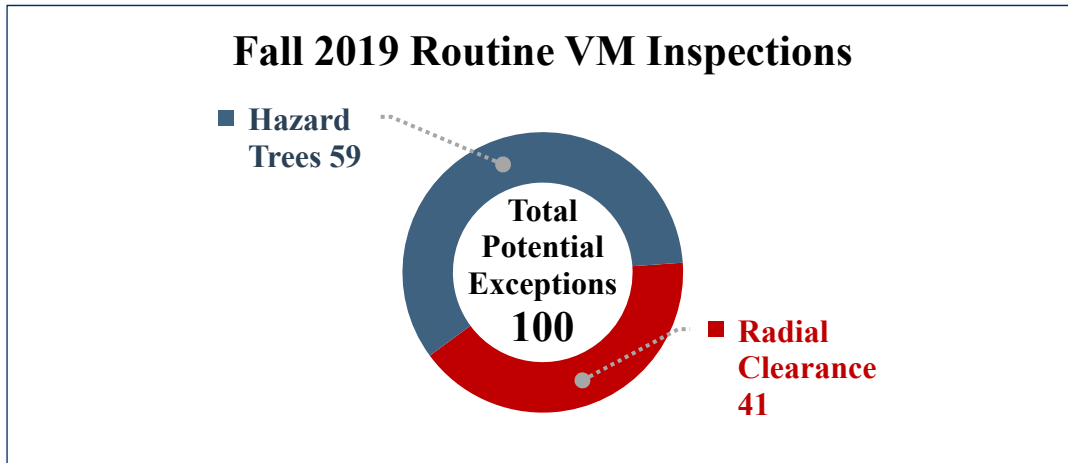
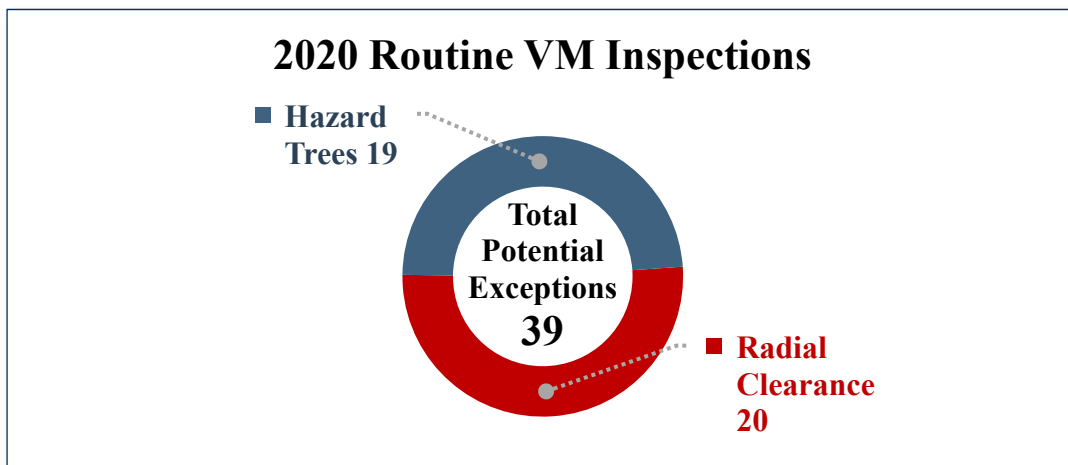
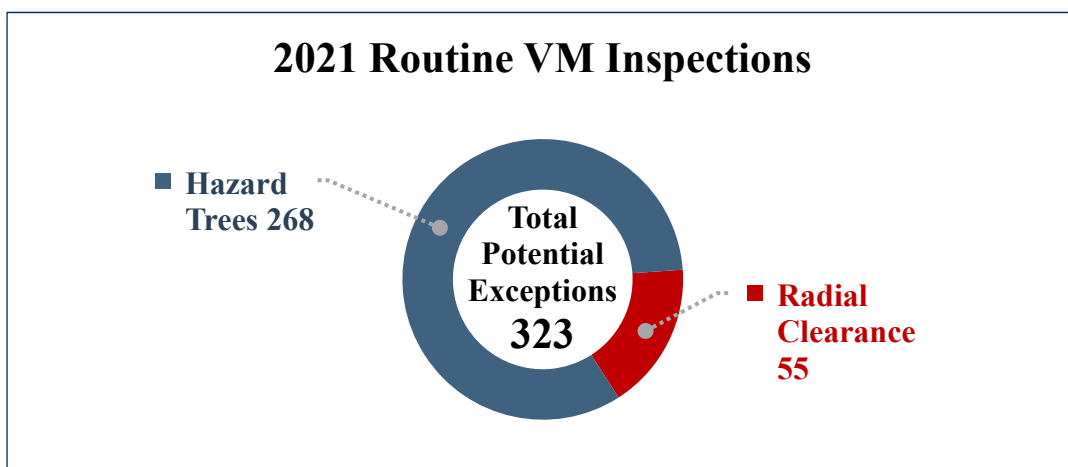
**EXHIBIT 5: ROUTINE VM INSPECTION STATISTICS**

For Monitor team inspections of Routine VM areas from 2019-2021, the three graphs below show the number of potential exceptions observed.

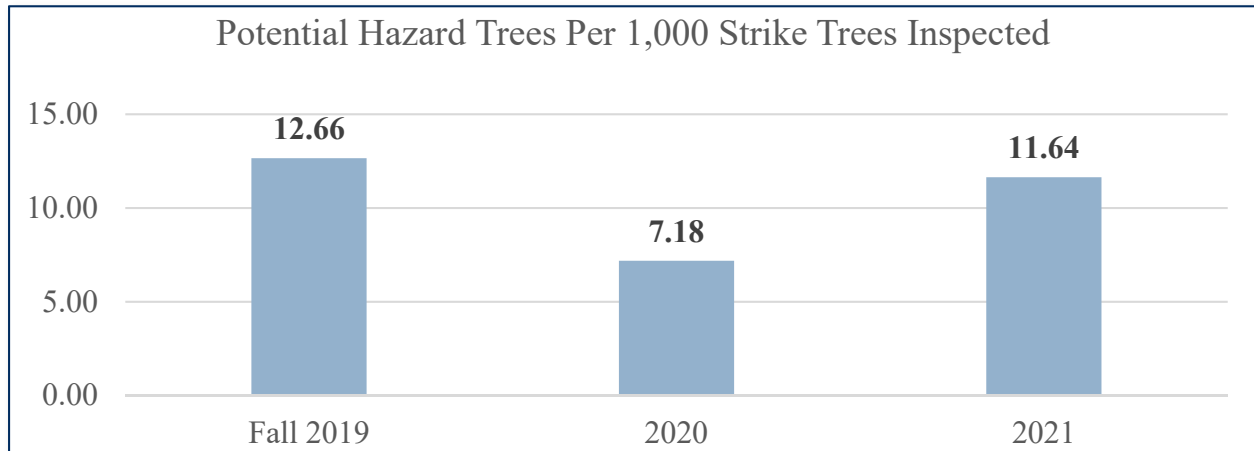
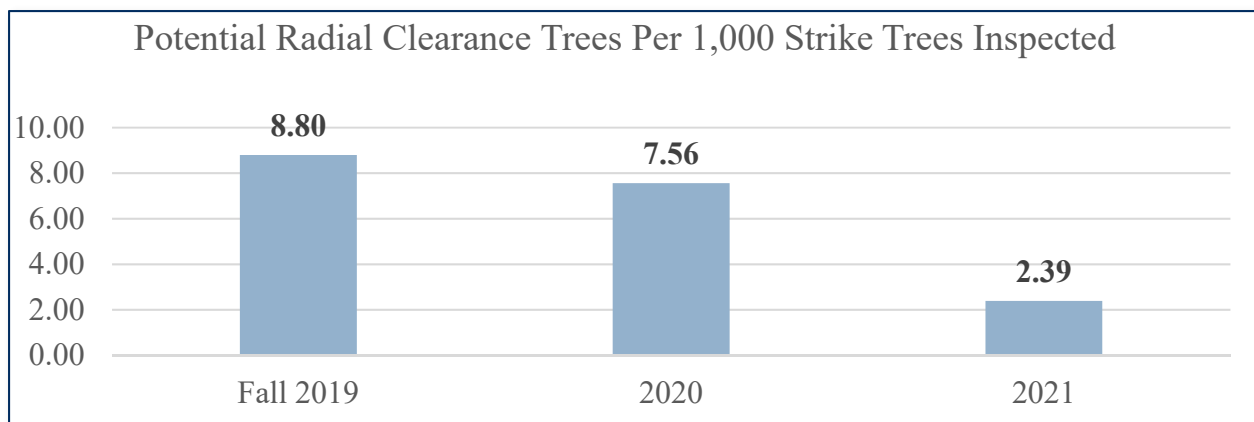
For Monitor team inspections of Routine VM areas from 2019-2021, the first graph shows the number of potential hazard trees observed per 1,000 strike trees inspected, and the second graph shows the number of potential radial clearance issues observed per 1,000 strike trees inspected.

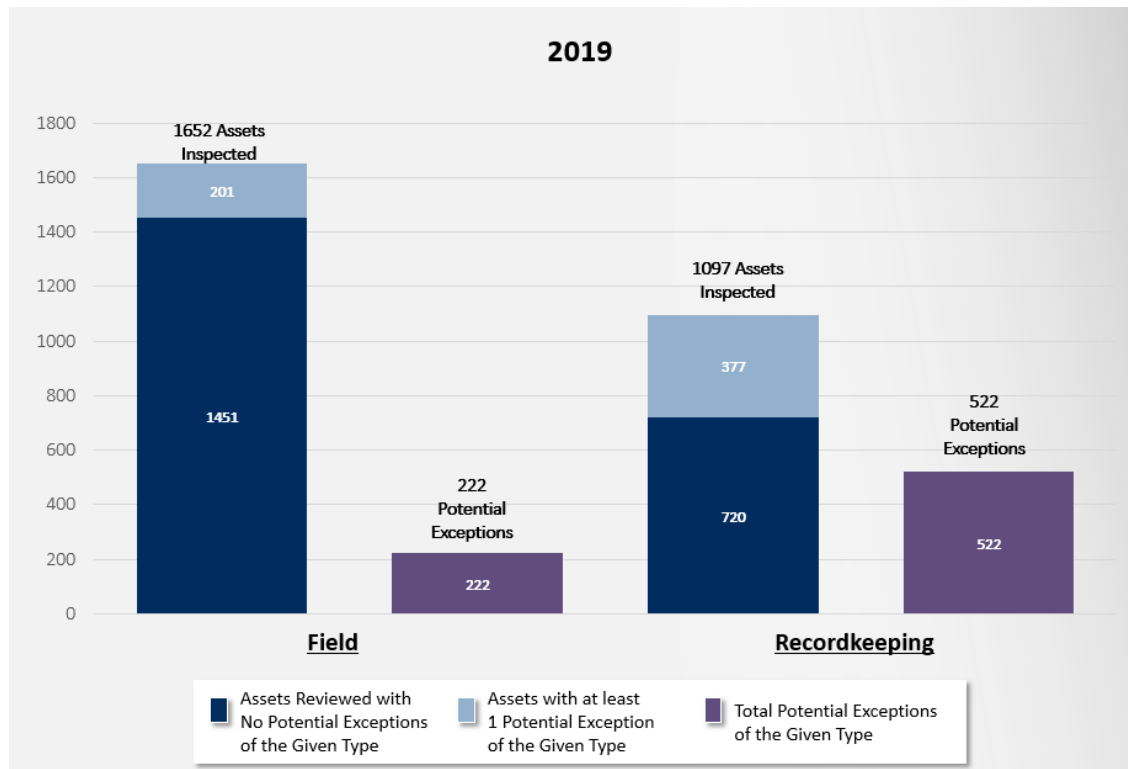
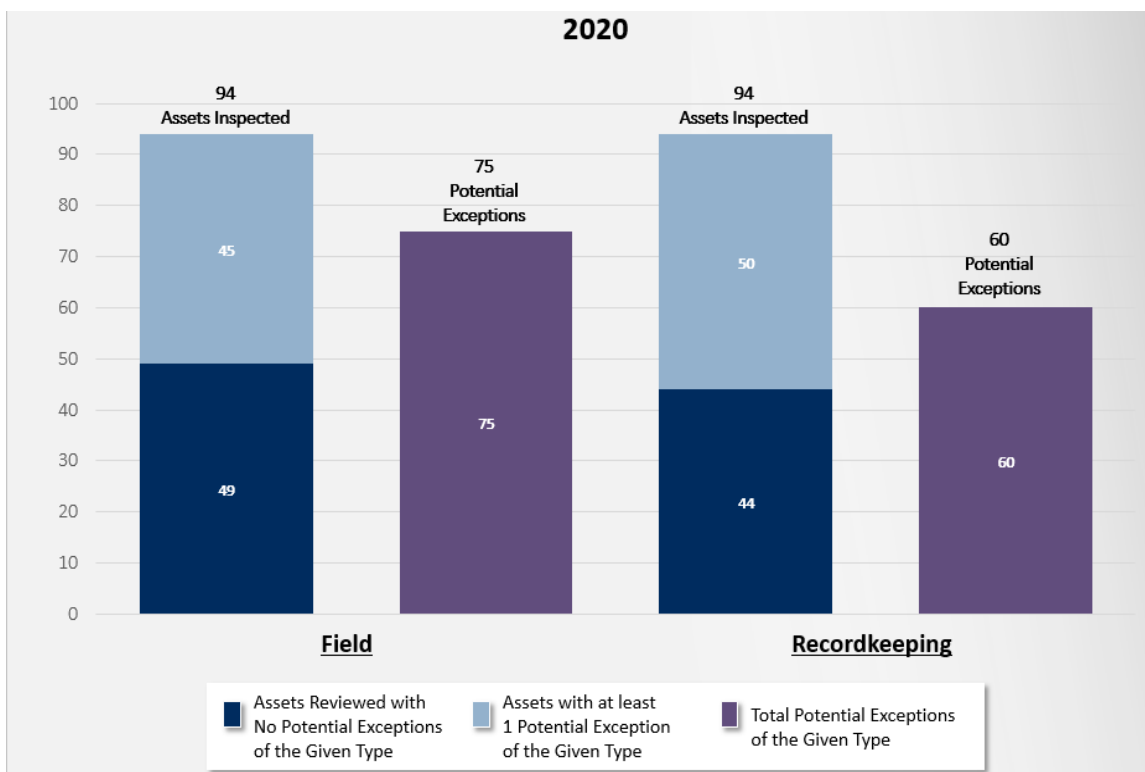
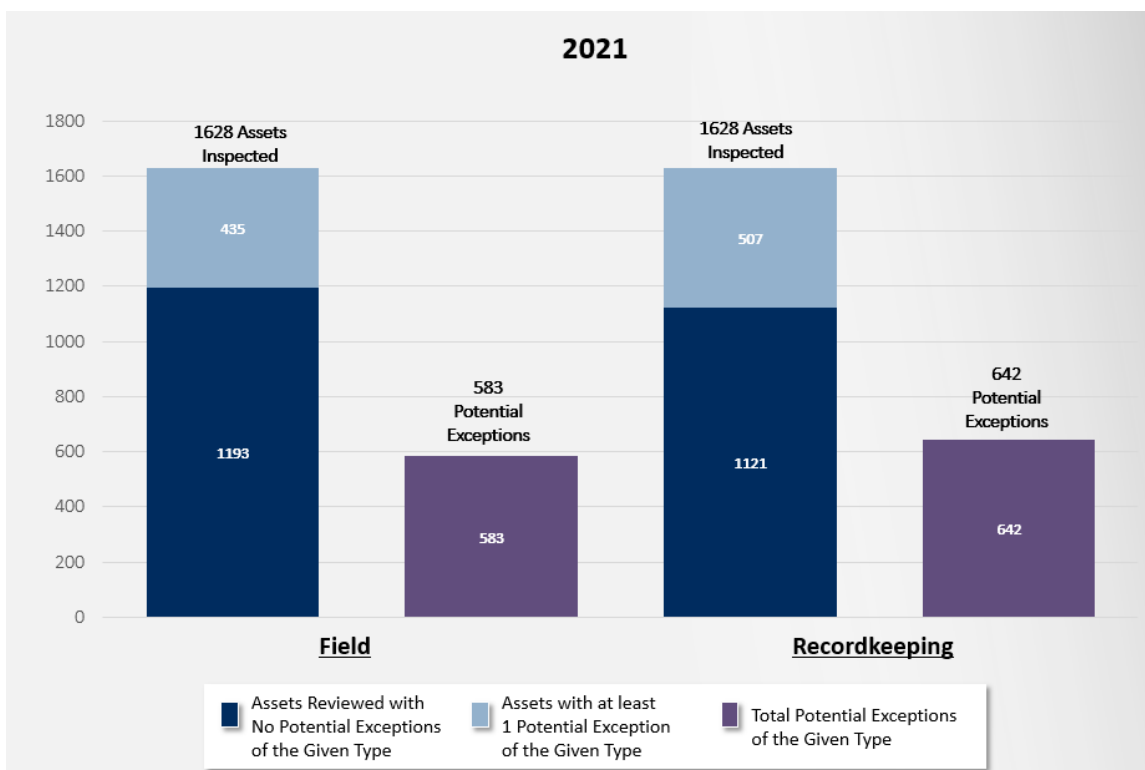
**EXHIBIT 10: REVIEW OF DISTRIBUTION INSPECTION FINDINGS (2019 - 2021)**

The graphics below show the number of distribution inspections reviewed by the Monitor team each year, as well as the number of potential exceptions recorded.

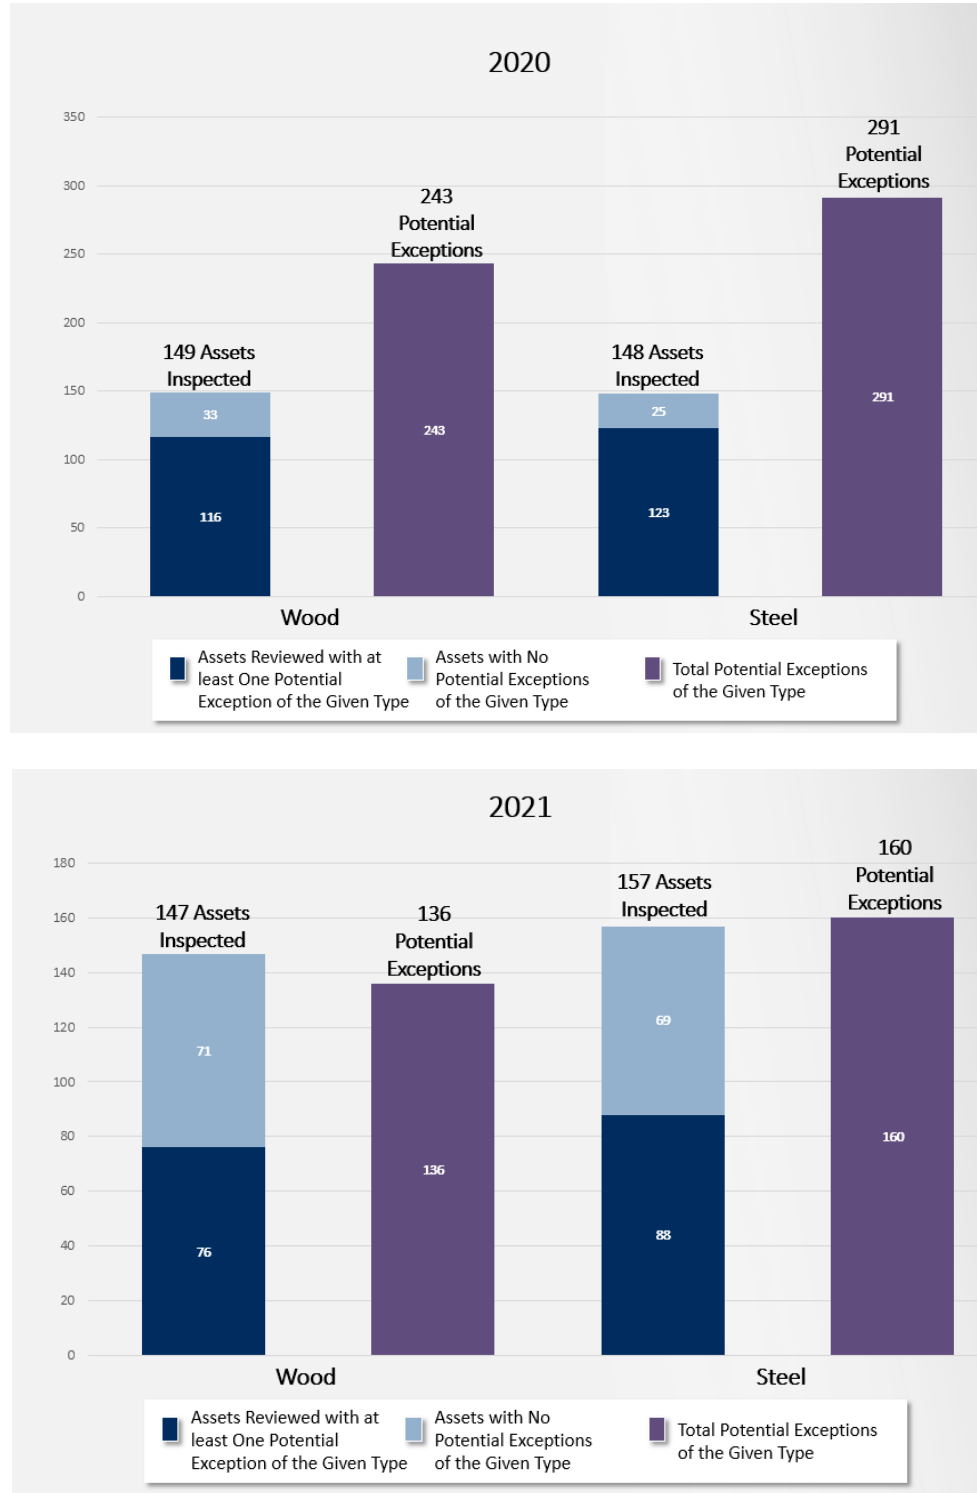
**EXHIBIT 11: REVIEW OF TRANSMISSION INSPECTION FINDINGS (2020 - 2021)**

The graphic below shows the number of transmission inspections reviewed by the Monitor team each year, as well as the number of potential exceptions recorded.

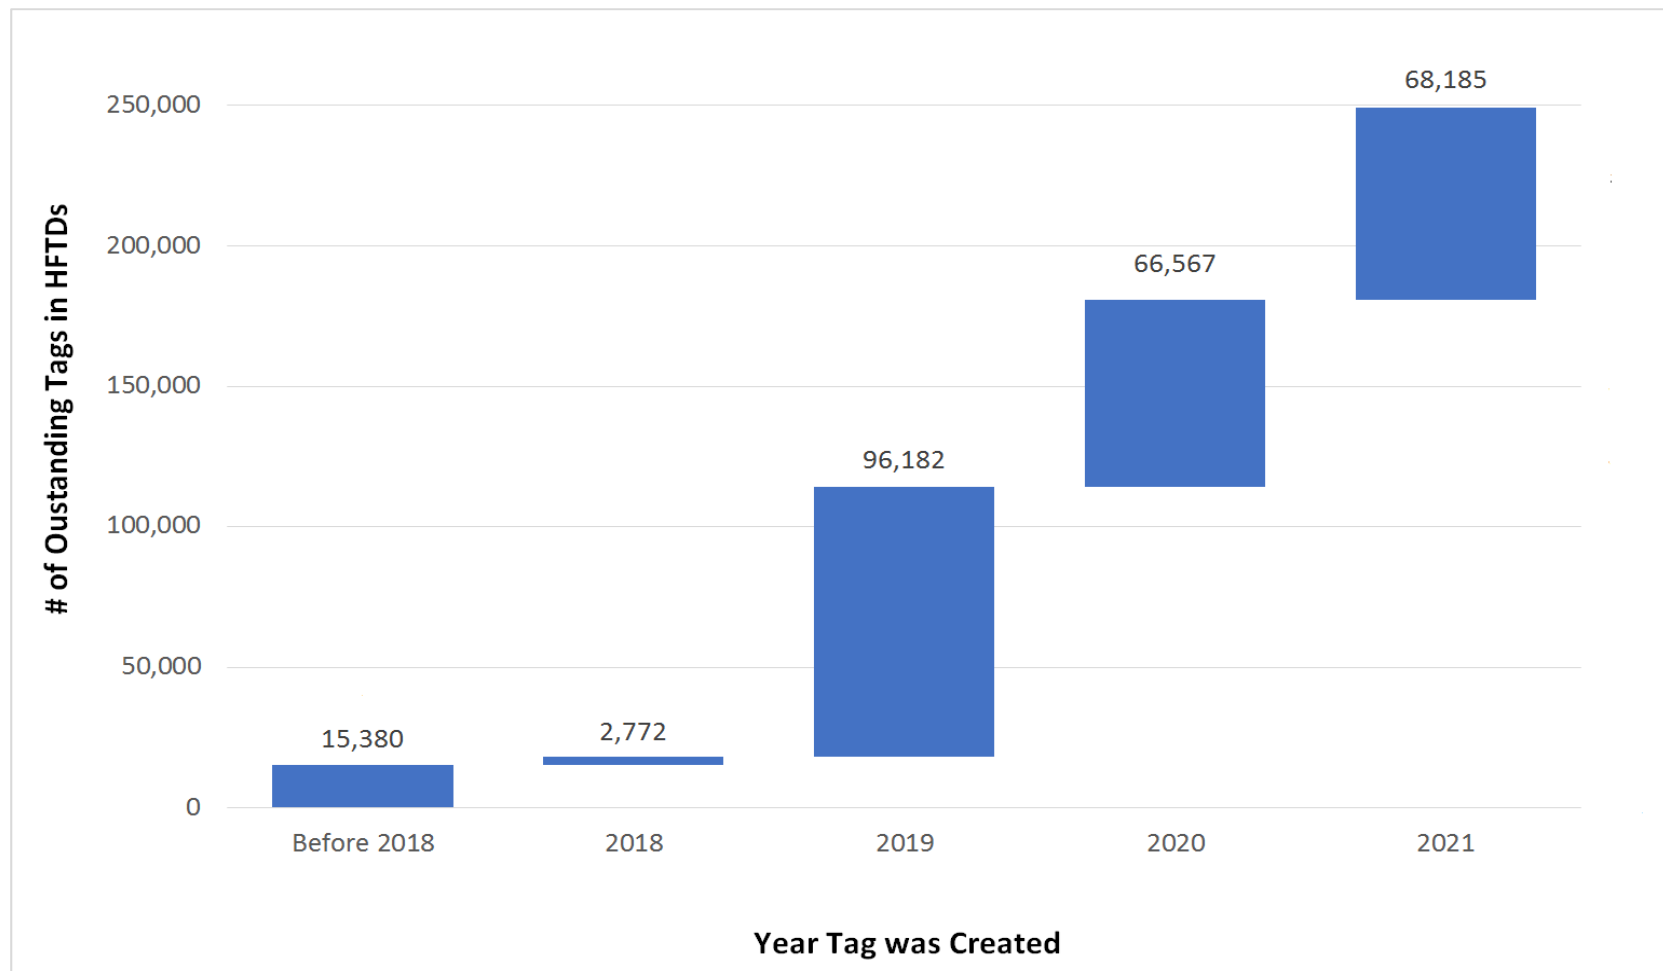
**EXHIBIT 12: INCREASING BACKLOG OF INFRASTRUCTURE-RELATED REMEDIATION WORK**

This graphic shows the increasing backlog of outstanding transmission and distribution tags through June 2021.
